**DESIGN VARIABLES
FOR
CUT SLOPES**

FINAL REPORT # FHWA/CA/TL-73/27

CALTRANS STUDY # D-5-30

Research Project
T.L. 632882
D-5-30

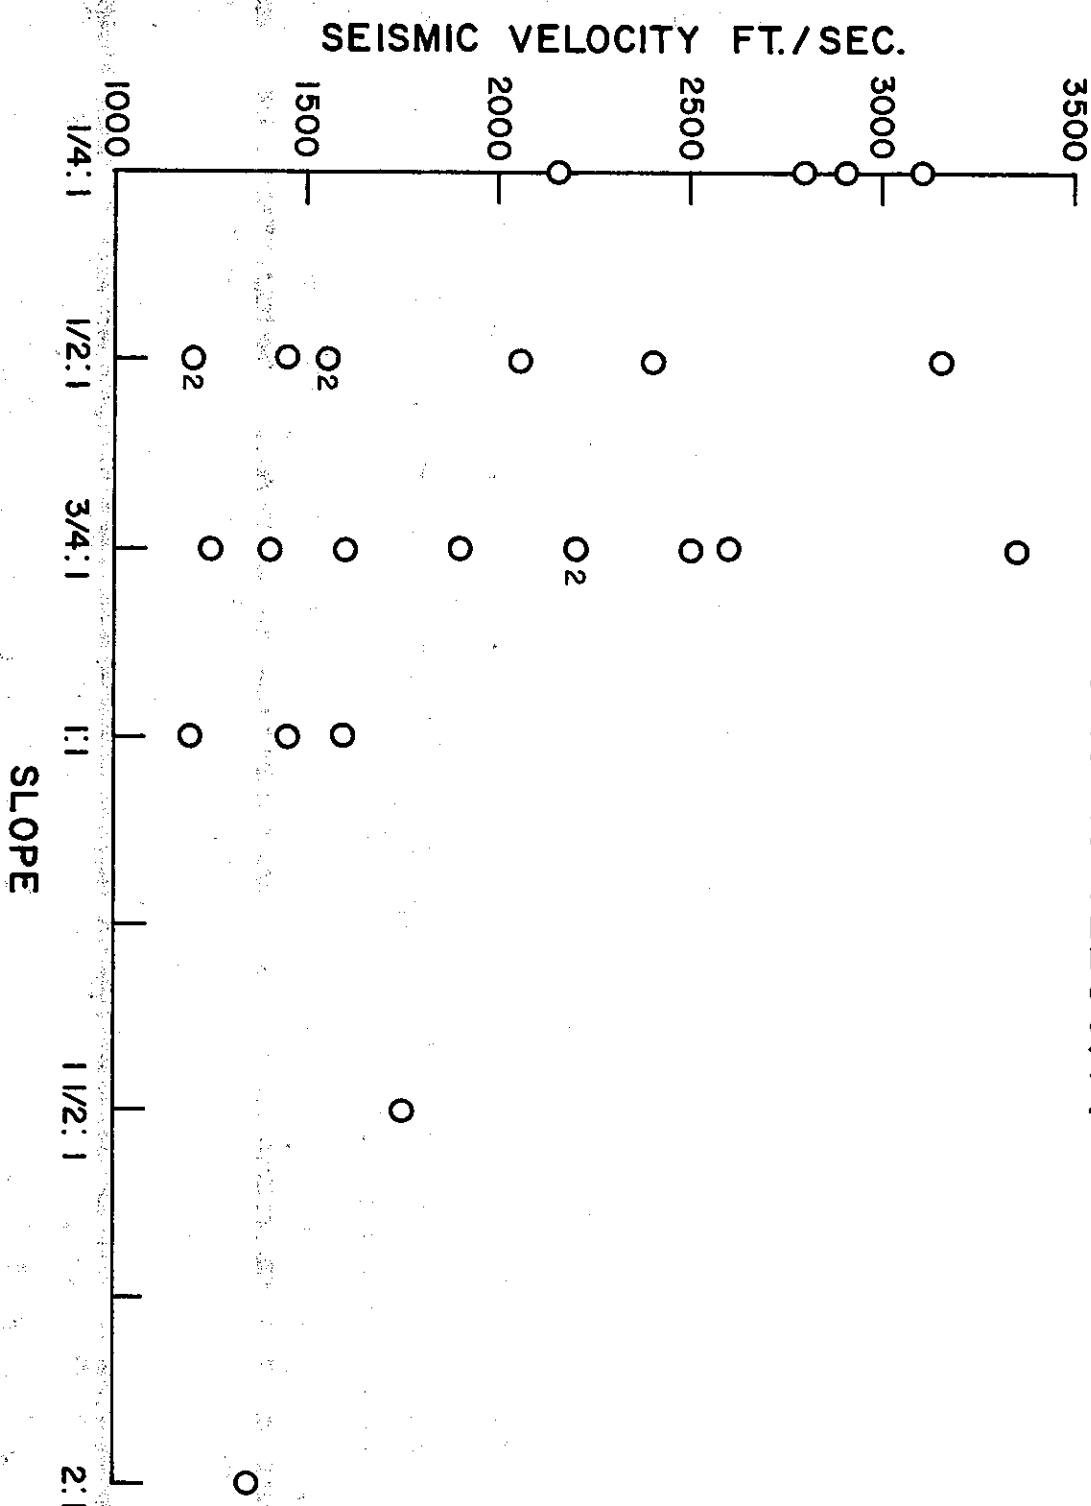
Figure 1

RELATIONSHIP BETWEEN STEEPEST STABLE SLOPE AND SEISMIC VELOCITY

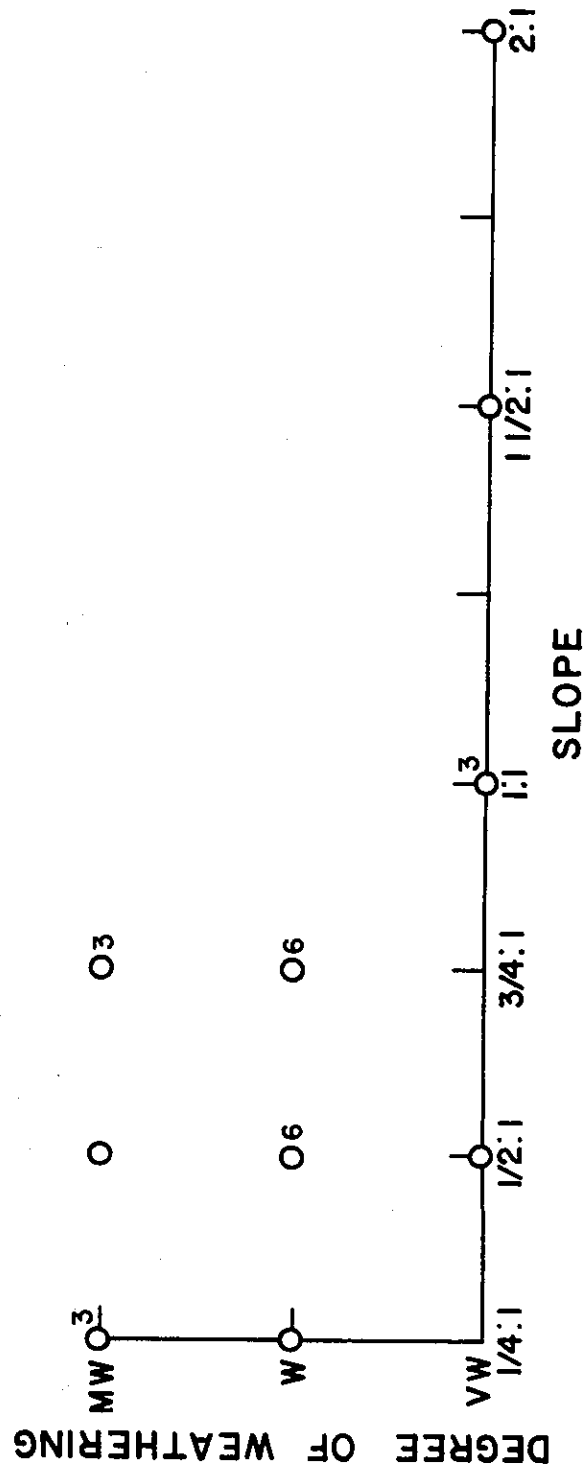
Figure 3

RELATIONSHIP BETWEEN STEEPEST STABLE SLOPE AND DEGREE OF WEATHERING
